SCREENING SITE INSPECTION REPORT
FOR
CANTON DROP FORGE & MFG. COMPANY
CANTON, OHIO
U.S. EPA ID: OHD004465142
SS ID: NONE
TDD: F05-9004-001
PAN: FOH0625SA

APRIL 8, 1991

SIGNATURE PAGE
FOR
SCREENING SITE INSPECTION REPORT
FOR
CANTON DROP FORGE & MFG. COMPANY
CANTON, OHIO
U.S. EPA ID: OHD004465142
SS ID: NONE
TDD: F05-9004-001
PAN: F0H0625SA

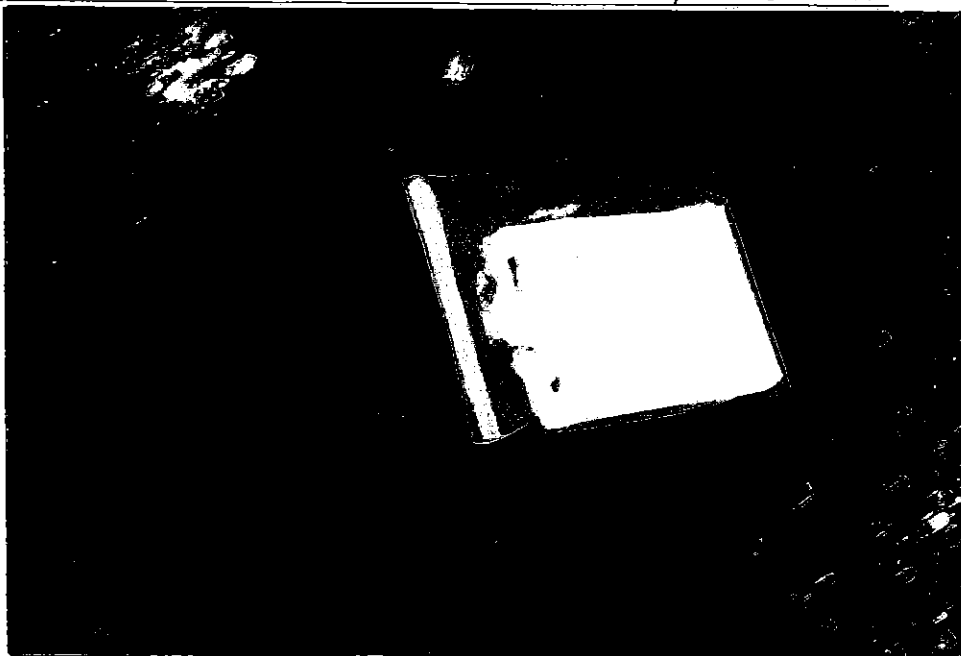
SAMPLE ID
(if applicable):
S-8

DESCRIPTION: soil sample S-8 collected from wrap
area
